MAXIMUM REACH ENTERPRISES

21 March 2014

MAXIMUM CAPACITY LIFT AMERICAN 9310 LIFT CRANE

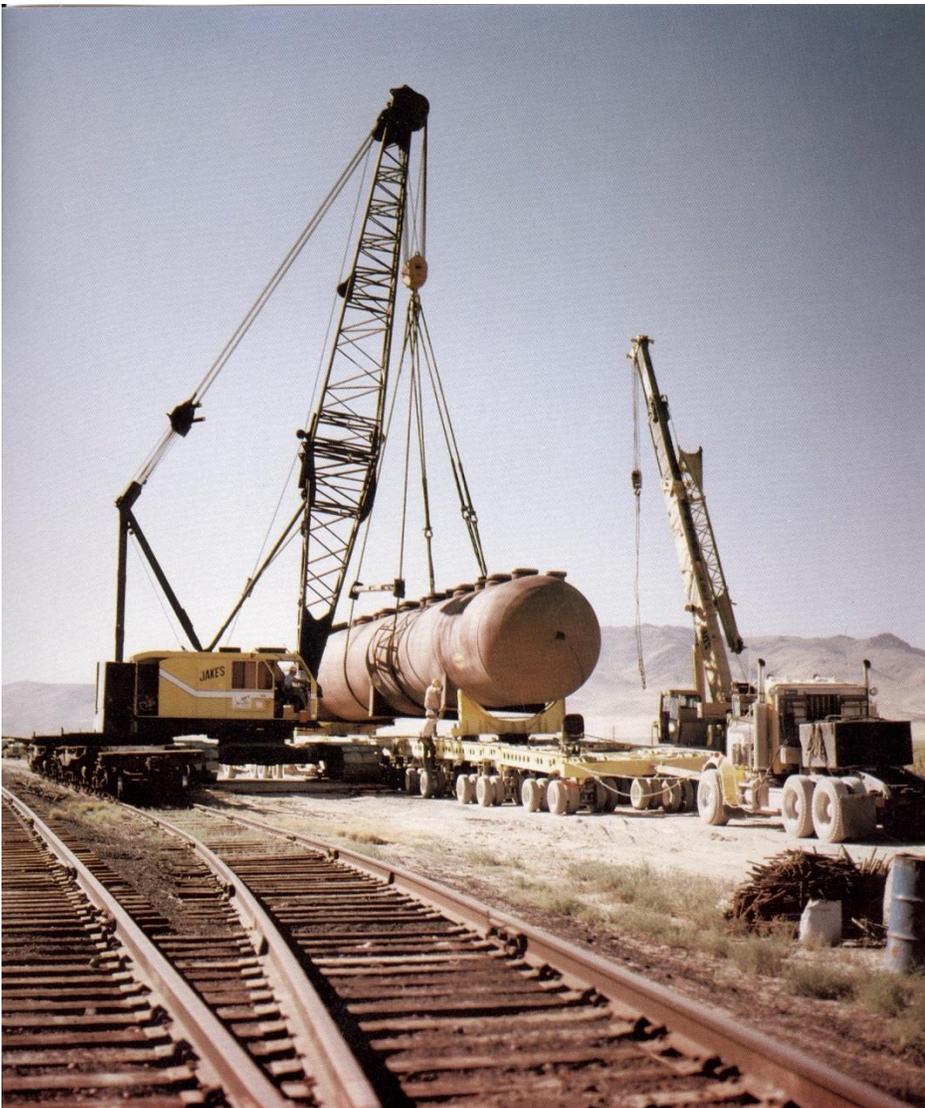
In 1988, Jake's contracted to move a 405,000 lbs. autoclave from a rail siding near Winnemucca, NV to the Getchell mine, a distance of about 20 miles. With the weight of the load block, the rigging and the saddles, the lift weight was 425,000 lbs. With a vessel shell weight variation of +/- 1/2 %, the total weight could have been close to 450,000 lbs. The maximum capacity of an American 9310 crawler crane with minimum boom of 70' and minimum radius of 17' is 450,000 lbs. See the photo of the autoclave being loaded on the transporter.

The first job assigned to him was the Autoclave move. I had finished the rigging drawings and had contracted with an excavation contractor in Winnemucca to go out to the rail siding and construct a lift pad for the AM 9310 right up next to the rail road ties. This wasn't a big job as the ground was a sandy gravel formation and only needed leveling and compacting. The plan then called for laying the ends of 7 ea. 1'x4'x24' crane mats up against the rail road ties so the crane tracks would be perpendicular to them when the crane was positioned for lifting. This meant that the autoclave would be lifted over the side of the tracks, swung 180° and set on the transporter. Again, see the photo to see how the crane mats were laid out perpendicular to the tracks.

When the crane was in place and the rigging hooked up, Dick instructed the signalman to start the lift. Instead, of the autoclave lifting off the railcars, the crane mat under the track on the load side started to sink. Dick called the excavation contractor and had him come back and excavate down 2', then backfill and compact it with a limestone base material. This took two days and \$5,000 to accomplish. The rigging crew then laid the two crane mats as before, walked the crane back up on them, hooked up the rigging and started lifting. They had the same results, ie, the crane mat on the load side started sinking.

As a side note, I didn't like the way that Dick had hooked up the spreader bar out of level, but it didn't affect its strength, it just looked bad. Dick just did not pay attention to details.

Now, I had a death in my family and had been gone when the lift was being setup, but got back to the office when the excavation contractor was redoing the lift pad. Jake's owner couldn't figure out why it was taking so long to off load the autoclave and why it was necessary to spend \$5,000 more on the lift pad plus two extra days of equipment rental, wages, room & board and demurrage on the rail cars. I drove to the rail siding and got there just as they were lifting the autoclave the second time. I noticed two things, 1) that the crane mat on the load side was sinking and 2) that only one mat was used under each track. I got Dick off to the side and asked him what the problem was. He said either the autoclave weighed more than we thought or the excavation contractor didn't do his backfill right. I pointed out that the problem was that he didn't follow the setup drawing. I asked him if he had brought more crane mats and he said yes, they were at the mine site. I told him that I was taking charge of the project and he was to return to the office immediately. I asked the rigging foreman to send a float and crew of riggers to bring back 5 crane mats. And then to walk the crane off the lift pad and to start laying the two crane mats we had per the drawing. As soon as the other mats arrived, they were laid into place. The crane was then walked back up on the mats as you see in the photo and the autoclave was easily lifted and swung 180° and set on the transporter without any settlement or problem.
