## MAXIMUM REACH ENTERPRISES

10 September 2016

# CONSTRUCTION OF I-15 THROUGH THE VIRGIN RIVER GORGE

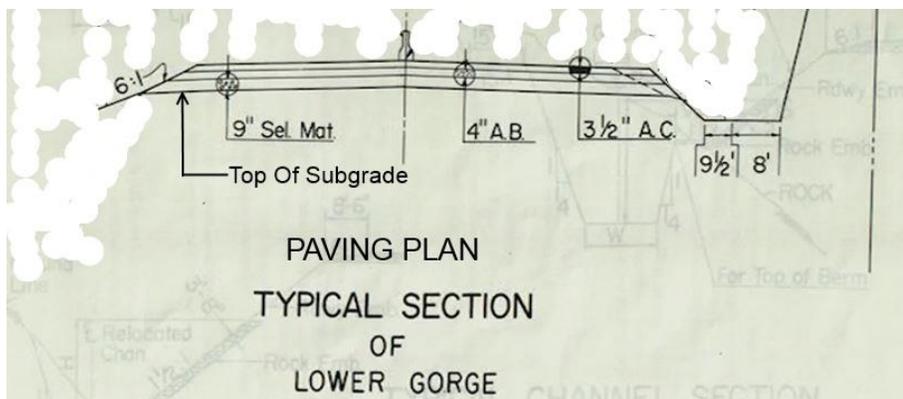
The next drawing shows what the typical paving plan looked like for the Lower Gorge. As stated above, this work was not included in Kiewit's contract and is presented here for information only and mainly just to show where the top of the subgrade is located.

In early 1969, Peter Kiewit Sons' Company received a contract from the Arizona Highway Department for constructing the **subgrade** for approximately 3.5 miles of I-15 through the heart of the Virgin River Gorge. The usage of the word "subgrade" is used here because the contract called for drilling and shooting the cut areas, moving the shot rock to the fill areas, watering and compacting it up to the top of the subgrade. There was no placing of crushed base material or asphalt paving included in the contract. This would be done later under a separate paving contract after this project was completed. See the drawing at the end of this section.

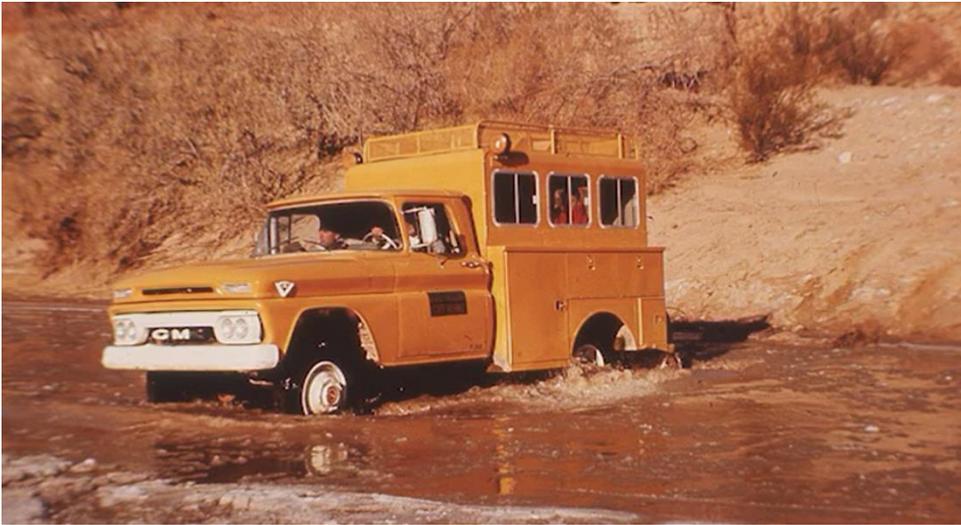
units, we decided that we had to bolt the radio units to the underside of the roofs of the cabs of the pickups between the driver and the passenger. 2) We soon found out that the lining on the brakes on the 40 Chevrolet pickups in our fleet were lasting about six weeks. We brought in 5 more pickups and used them to rotate the fleet thru the Chevrolet dealer in St. George to keep up with the brake replacements without disrupting our daily operations. The photo below shows one of the 18 river crossing.

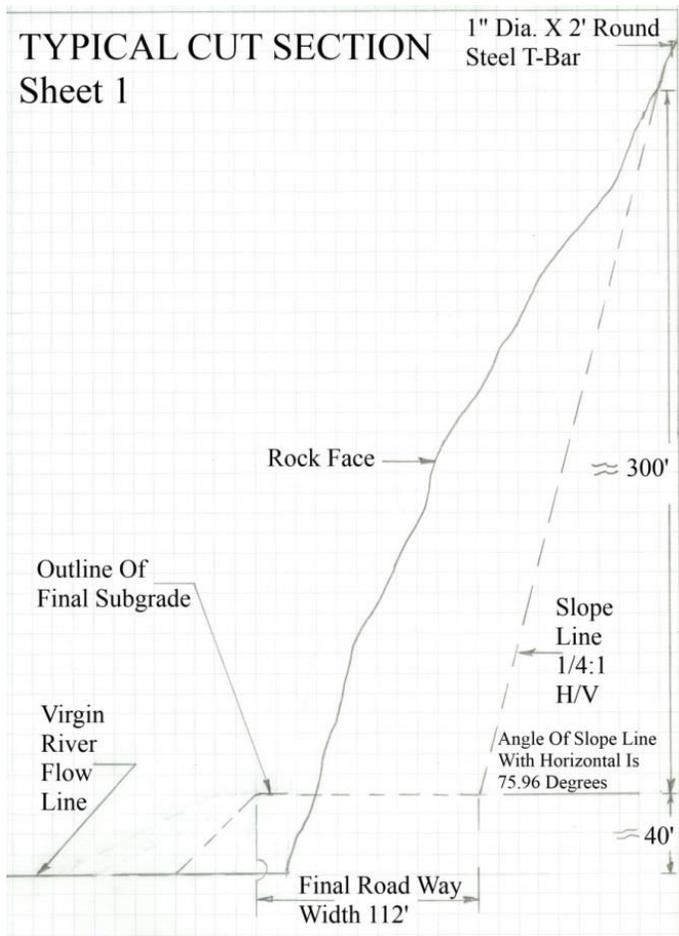
With the air piped to the top of the cut, two rock climbers climbed about 30' above it carrying small dia. air hose, a small jack hammer, 1" T-bar and epoxy. After drilling the hole and installing the 1" T-bar, they hung two rappelling ropes down from it and moved over to the next location and repeated the operation. This sounds like a pretty simple operation but there was a lot of passing ropes back and forth with grunt buckets filled with tools by laborers on the side of the cut. See the typical cut section, sheet 1 which shows the 1" dia. T-bars about 30' above the top of the cut.

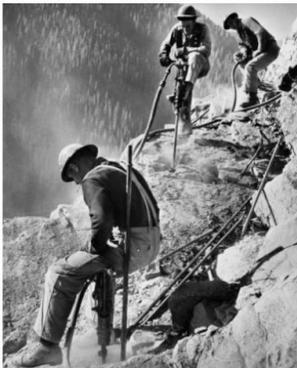
When the drillers had blasted the rock down so that a ledge was starting to form, then in addition to the slope holes, the drillers started drilling vertical burden holes on a 2' x 2' pattern. See the photo below.

Large Jack Hammers At Work. No rappelling ropes shown as the drillers are working on a ledge. The jack hammers drilled a 2.5" dia. hole.

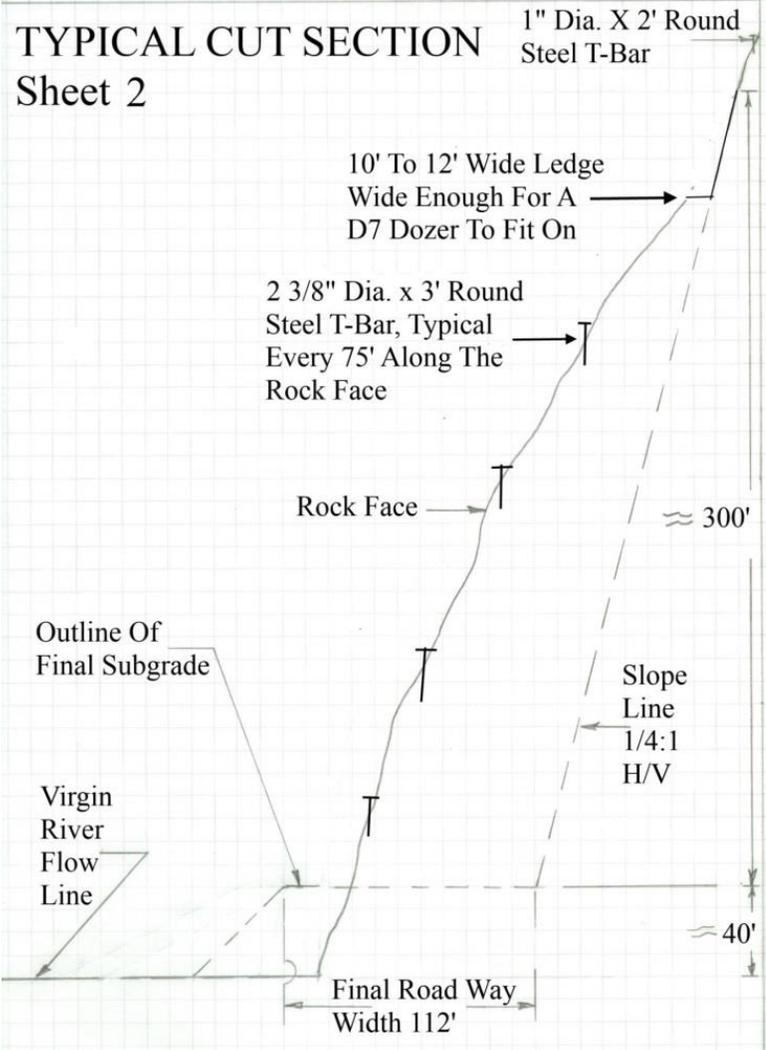
As soon as the shot rock was shoveled into the canyon, 1" T-bars were installed on the lip of the ledge and rappellers went down and scaled the rock face so there wasn't any loose rock left that could fall and hurt someone below, as it might be dislodged by the blast from another cut. The scaling operation was repeated after every blast. This drilling operation was repeated until the shot ledge was about 10' to 12' wide. At this point drillers rappelled down the rock face and drilled and installed 2 3/8" T-bars about 75' apart. A 2" dia. steel pear link with two large diameter slings, one 15' long and the other 5' long, was hung from each T-bar. See the typical cut section sketch, sheet 2.

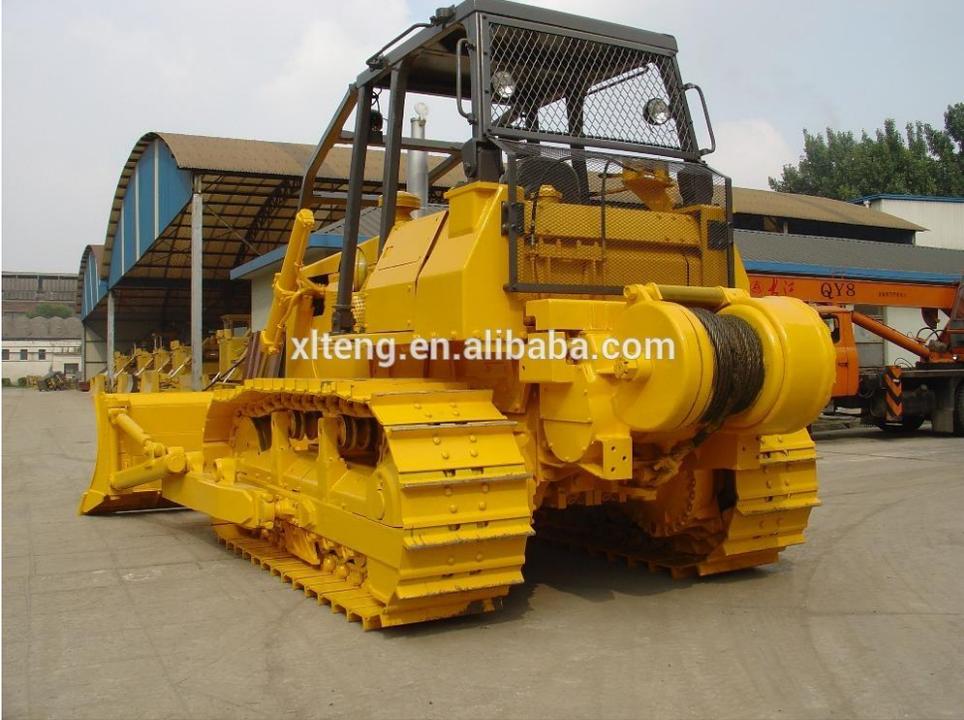
D7 DOZER WITH A WINCH MOUNTED ON THE REAR. Note the hook on the winch line is attached to the drawbar just below the winch. The drawbar is typical on all dozers.

Now it was time to bring the D7 Caterpillar dozer into action. The operator of the D7 was Jock Carnes. I don't know if the Operators Union sent him out to specifically operate the D7 or if Kiewit supervision asked for volunteers due to the danger involved and Jock was the only volunteer with enough nerve to do it. Jock backed the D7 up to the rock face of the cut. He then started letting out on his winch line and the laborers threaded it around a single sheave block and hooked the dead end to the draw bar on the dozer. This made what is called a two part line and provided twice the pulling power for the winch. Laborers up on the cut throw a rope down and the laborers by the dozer hooked it to the top of the sheave block. Jock then began to let out more winch line and the laborers up on the top of the cut pulled the sheave block up the face of the rock until it could be hooked to the 5' sling on the nearest T-bar by two rappellers. Jock then started backing up the rock face by taking in on his winch line and powering the tracks of the dozer. As soon as the D7 got up to the first T-bar, the rappellers hooked the 15' sling to the draw bar. He then slacked off on his winch line until the draw bar sling was tight. He then let out on his winch line and the rappellers unhook the sheave block from the 5' sling. He continued to let out on his winch line and the laborers at the top of the cut pulled the sheave block up to the next T-bar. This operation was repeated until the D7 was up on the ledge.

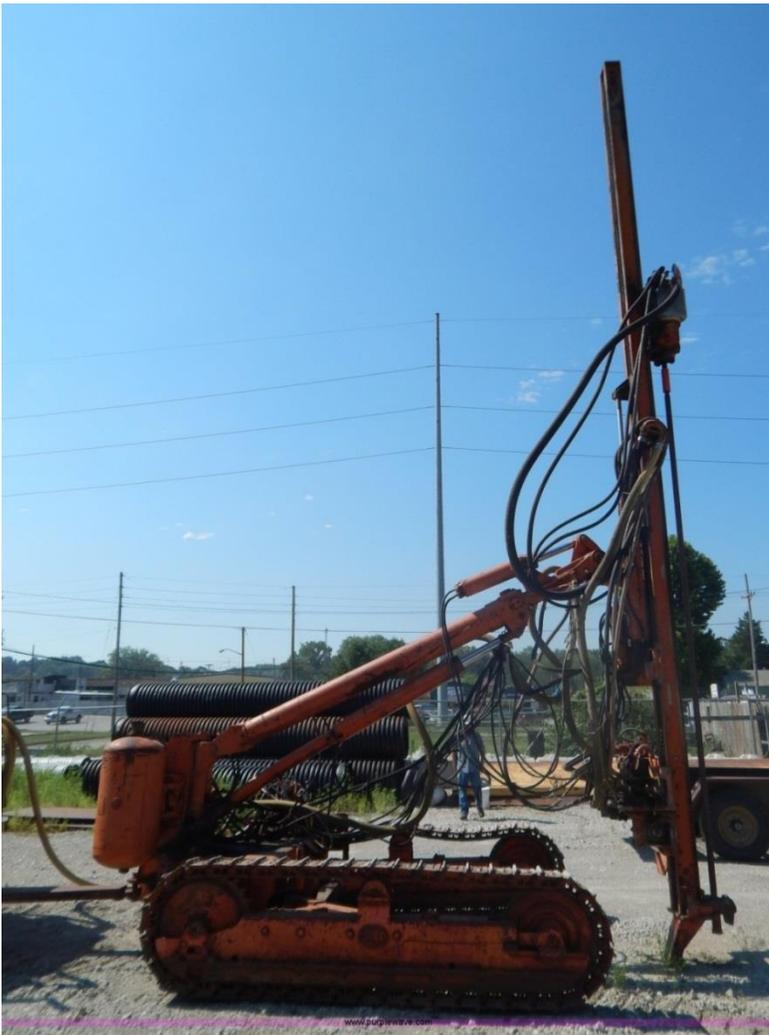
Typical Air Track Rock Drill, drilled a 3" dia. hole

When the D7 was finally up on the ledge, Jock would back it up to the edge of the cut and the drillers would anchor it with 2 each 1" T-bars. He would let out on his winch line as a single part and laborers on the bottom would pull the end down with a rope and hook it on to an air track rock drill. By radio communication, Jock would start to winch the air track up the rock face and the air track operator would also help out by adding air power to its tracks. When it was pulled up on the ledge, Jock pulled another one up. As a side note, there was only one air track operator who had nerve enough to bring an air track up the rock face. He did it for all of the other air tracks. One of the air tracks would start drilling 3" dia. slope holes, 3' apart and 15' deep. The other air track would start drilling 3" dia. vertical burden holes on a 3' square pattern. Jock would then pull up two light plants so the night shift could have good lighting. Jock would then start making a ramp around the corner from the cut area into the gully so that all of the equipment could be moved there before the next blast went off.

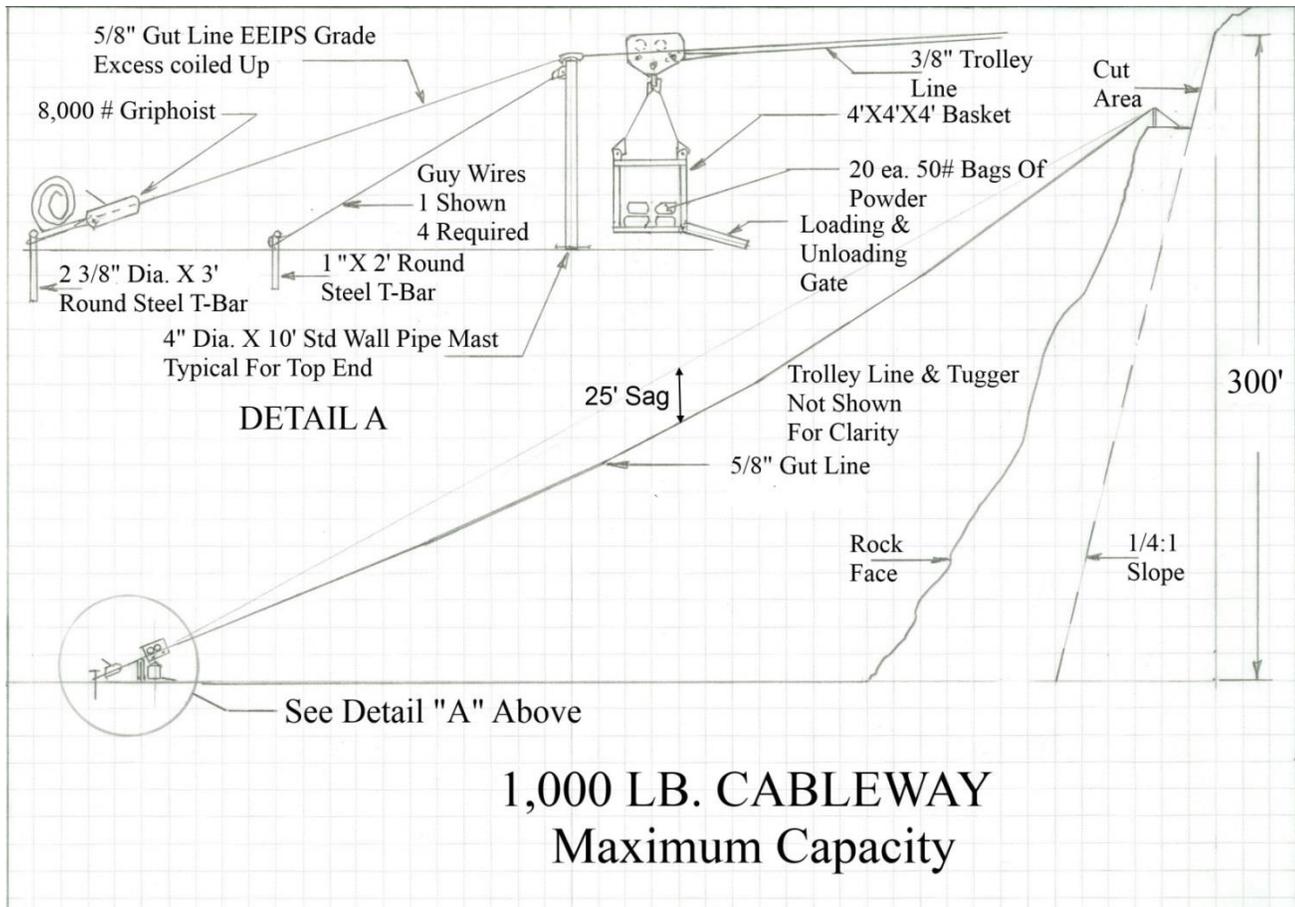
It was at about this point on the first cut that it became apparent that using laborers to carry the 50 lbs. bags of powder up on the cut was not going to keep up with the amount required. So we designed a small cableway that had a maximum capacity of 1,000 lbs. This meant that it could carry 20 each 50 lb. bags of powder per trip, or a hundred gallon diesel fuel tank per trip, or all of the ice water, lunches, drilling tools, mechanic tools, parts, etc., that was needed to keep the drilling of the cut going in an efficient manner. See the sketch below showing the cableway. It was light enough that the top mast could be relocated and guyed off on the cut ledge after each shot and re-tensioned using a large grip hoist at the bottom. A Sauerman continuous cable clamp, similar to the one in the photo was installed just above the grip hoist as a safety. The 3/8" dia. trolley line was hooked to the trolley, ran up to the top mast, around a sheave, back over a sheave at the trolley, down & over a sheave at the top of the bottom mast and on down to an air tugger. A high speed air tugger, not shown in the sketch, pulled the trolley line so that a load of powder could be moved from the canyon floor to the top of the cut in under 10 minutes. It was not designed for carrying personnel, so the workmen still had to walk up the gully at the start of their shift and back after the shift. But they could do it without having to carry anything.

The trolley ran on the 5/8" dia. gut line.

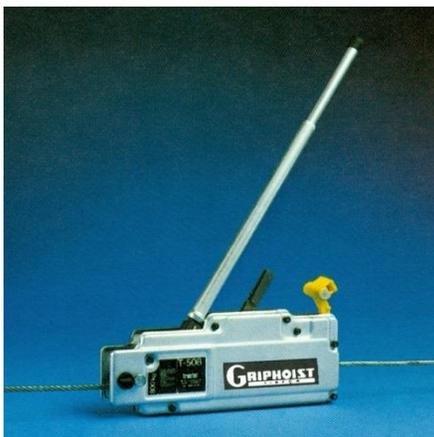
Griphoist, 8,000 lbs. pulling capacity for tensioning the unloaded gut line to about a 25' sag.

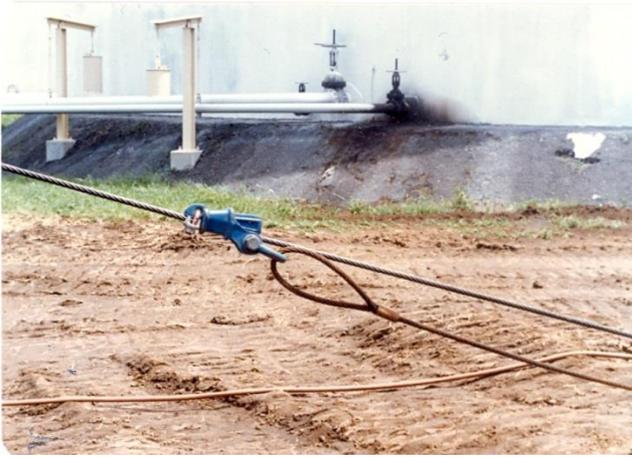
Sauerman Continuous Cable Clamp. Safe Working Load same as the gut line.  
Used as a safety with the sling hooked to the T-bar anchor at the canyon bottom.

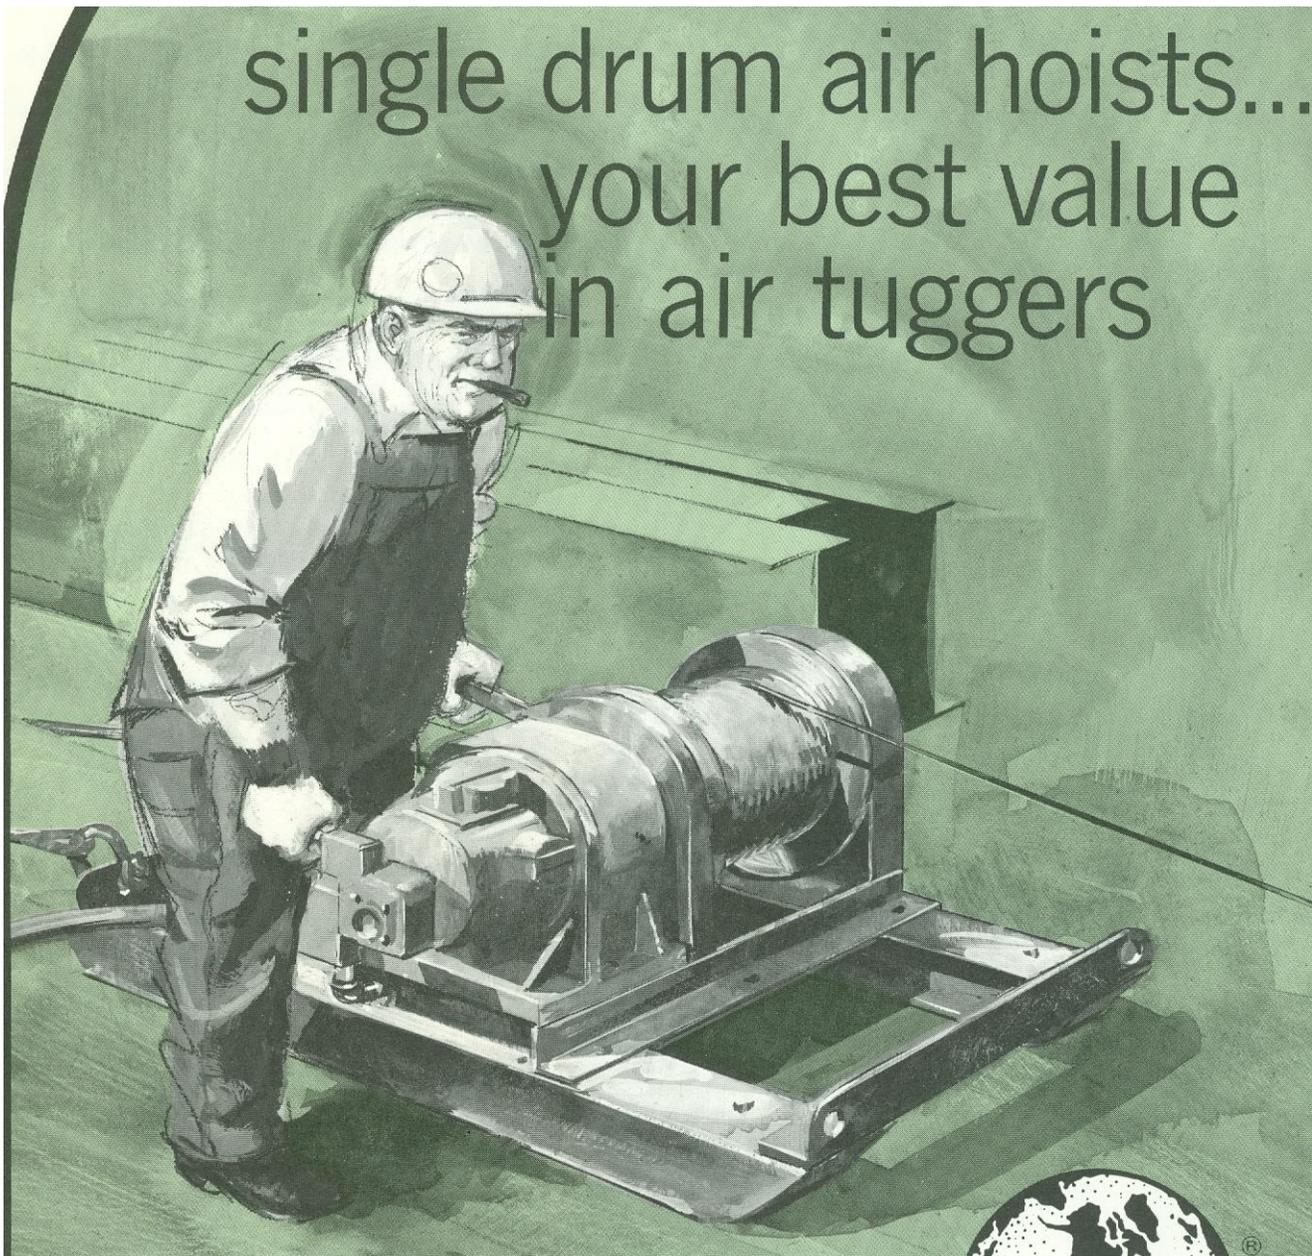
Air Tugger, 5,000 lbs. pulling capacity, 110 fpm line speed

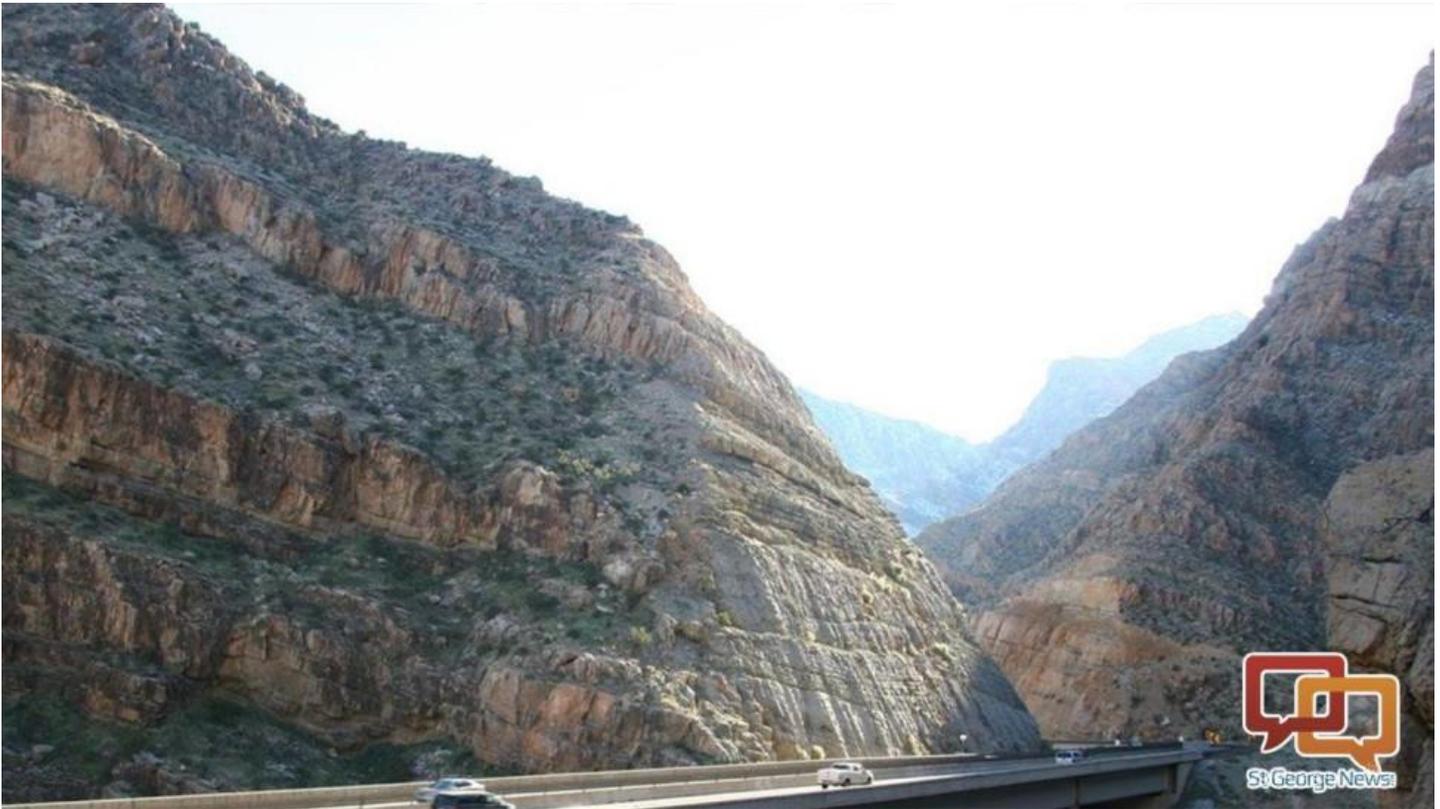
When the blast went off, the powder in the slope holes was set to explode a couple milliseconds before the powder in the vertical burden holes was set off by using delays in the caps. The energy from the powder in the slope holes, seeking the path of least resistance, went from slope hole to slope hole, cracking the rock face in a straight line. Then the vertical burden holes exploded and the shot material rose up in the air. The material around the slope holes then slid down off the slope into the void left by the burden material, leaving pretty much a smooth rock face or slope with only the half round 3" pre-split drill holes showing. The slope required very little scaling. This type of slope drilling is very evident as one drives through the Virgin River

Gorge and looks at the smooth cuts that look like they have been cut with a butter knife. For an example of this, see the photo of the cut just below bridge 6.

PHOTO OF BRIDGE SIX, looking South downstream.

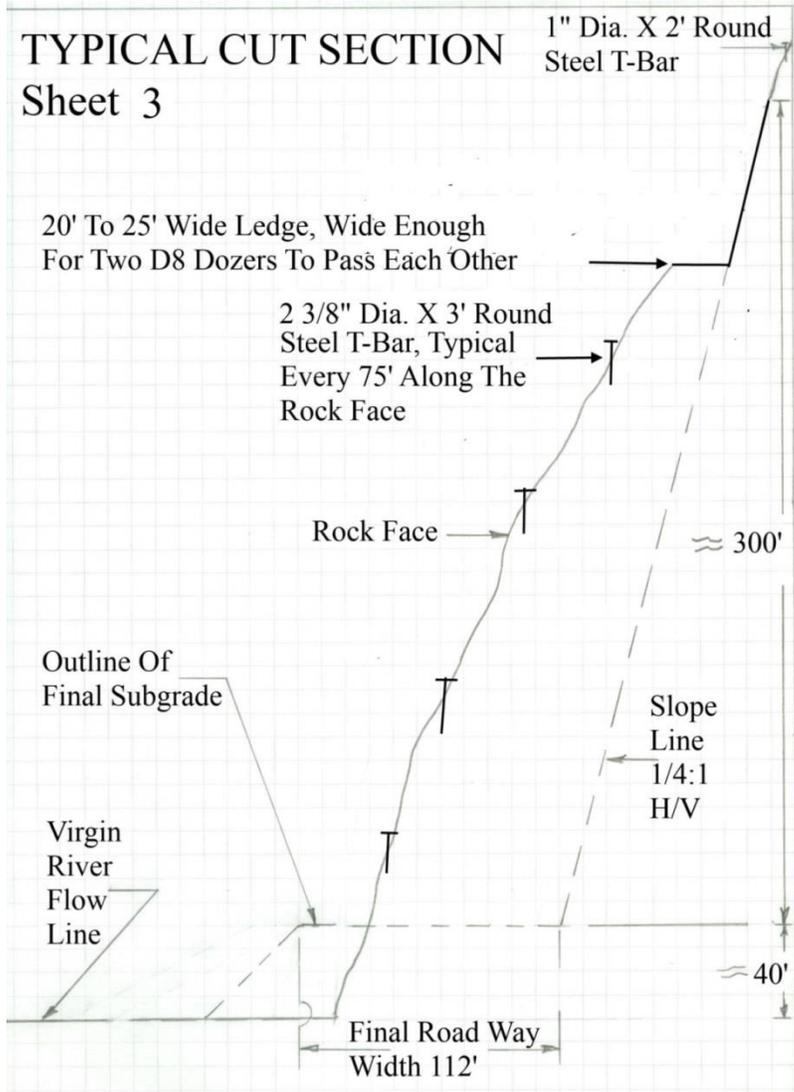
## Sheet 3

This process was repeated until the ledge was about 20' to 25' wide, wide enough for two D8 dozers to pass by each other. See Sheet 3 below.

# TYPICAL CUT SECTION

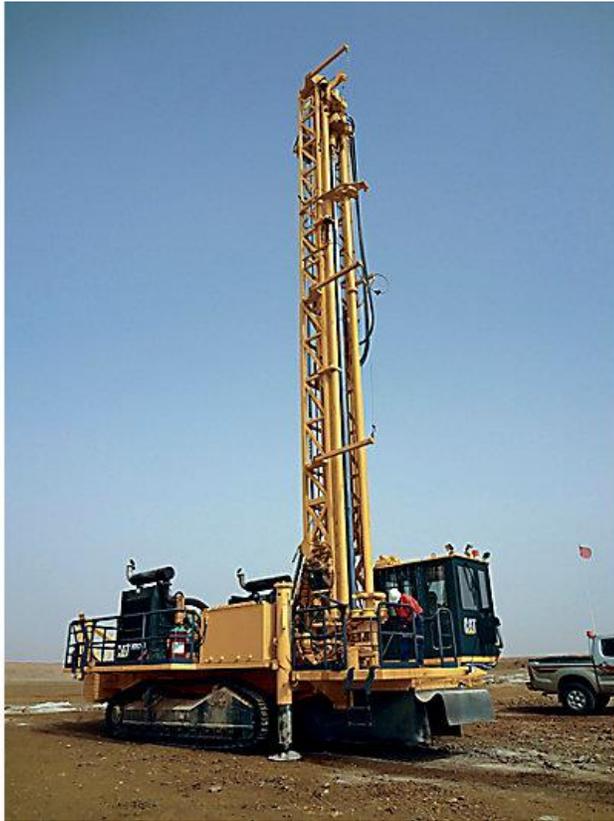
Robbins Rock Drill Mounted On A D8 Caterpillar. Drilled a 9" dia. vertical hole

The air tracks were then used strictly to drill the slope holes and the Robbins Rock Drill was used to drill 9" dia. vertical burden holes on a 7' square pattern. The depth of the drilling holes would now be 30'. While the ledge was being drilled out, the D8 dozer would do what the D7

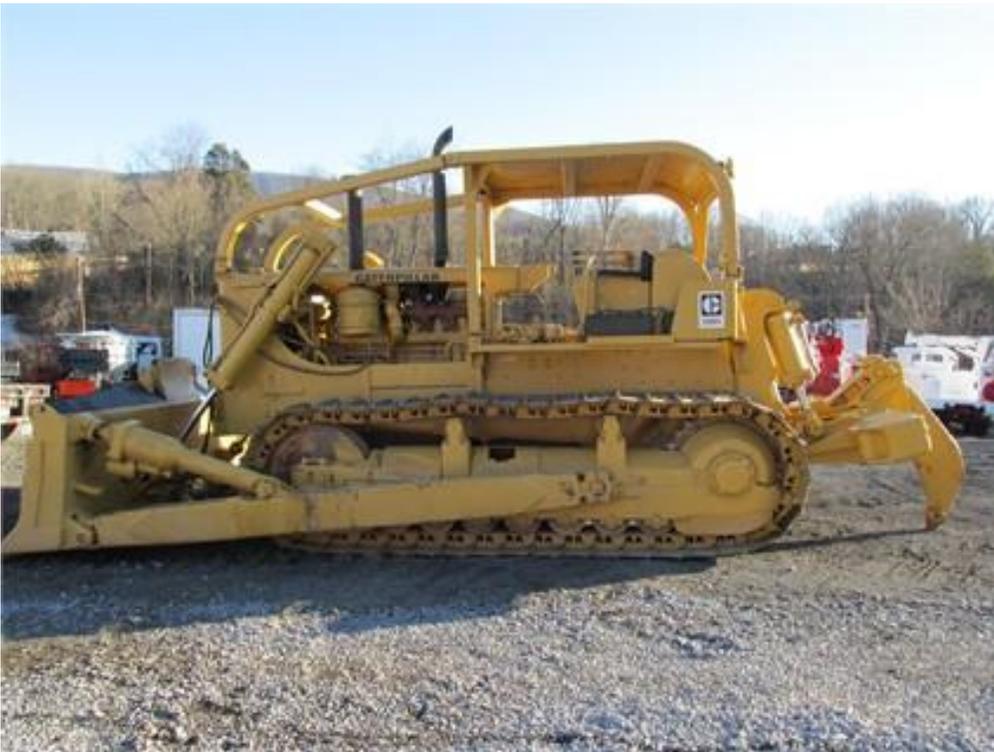
D8 DOZER WITH HYDRAULIC RIPPER

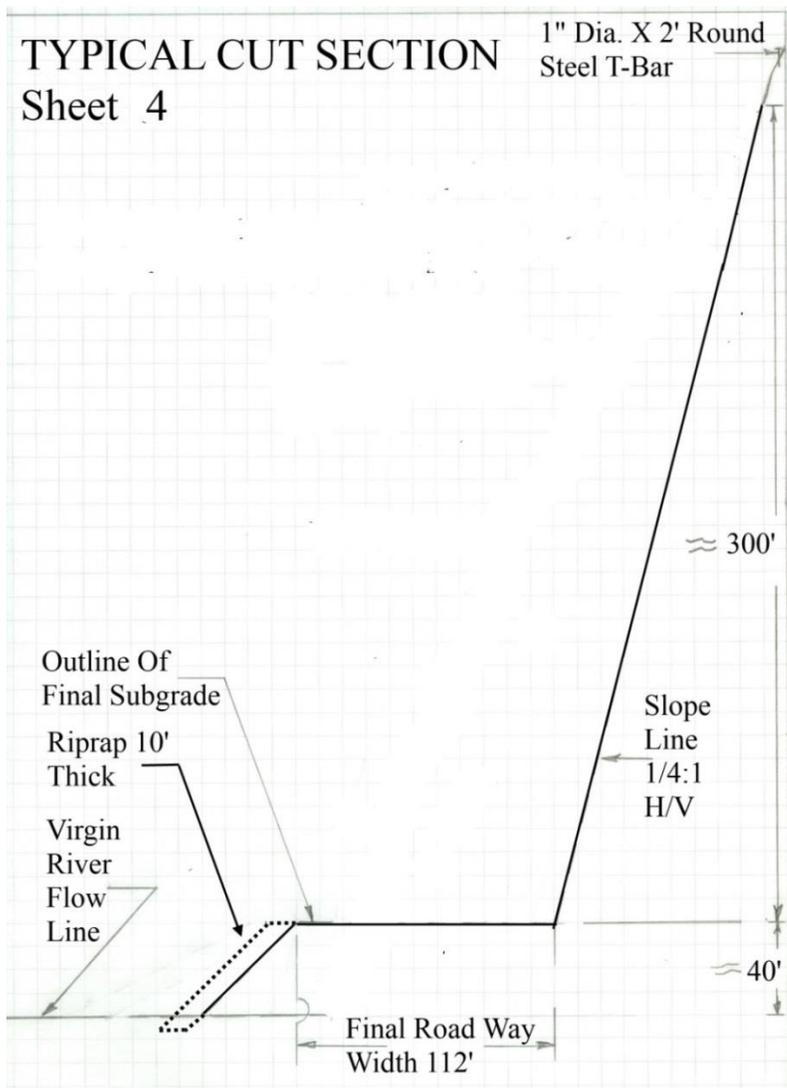
As there was no way to bring up any other equipment with the D7 gone, this equipment would be used to drill and shoot the cut down to the sub-grade level. See Sheet 4.

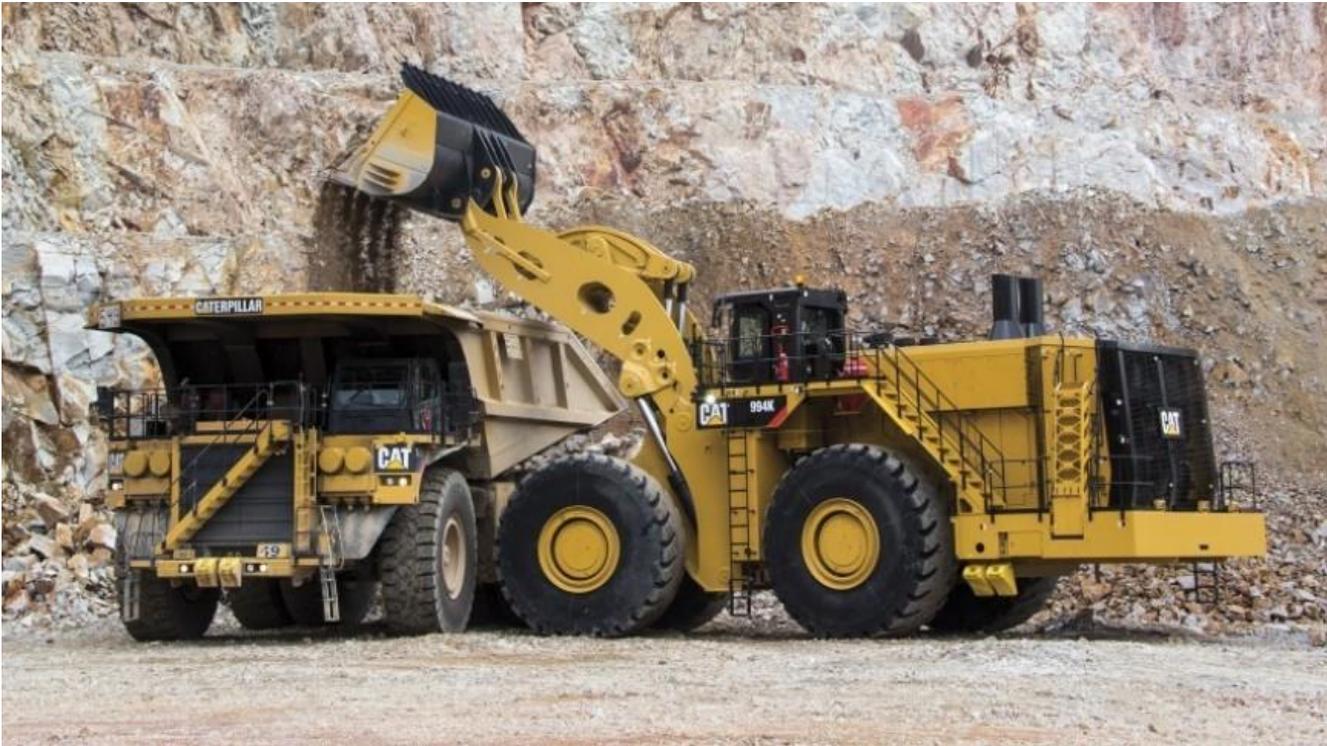
As soon as the dozers finished shoving the shot rock off the ledge of a cut, a 992 Cat front end loader would move in on the canyon floor and start loading 50 ton rock trucks. If the cut material had to be moved to fill areas both up the canyon and down the canyon, then a second 992 loader and rock trucks would be set up on the opposite side of the rock slide. They would clear the canyon bottom as fast as they could so that it could be opened up to vehicle traffic. The weight of one bucket of shot material  $\approx 10 \text{ cy} * 1.5 \text{ ton per cy} \approx 15 \text{ tons}$ . Therefore, it normally took 3 heaping buckets of shot material to load a 50 ton rock truck.

A 992 Caterpillar 10 cy front end loader, loading a 50 ton rock truck

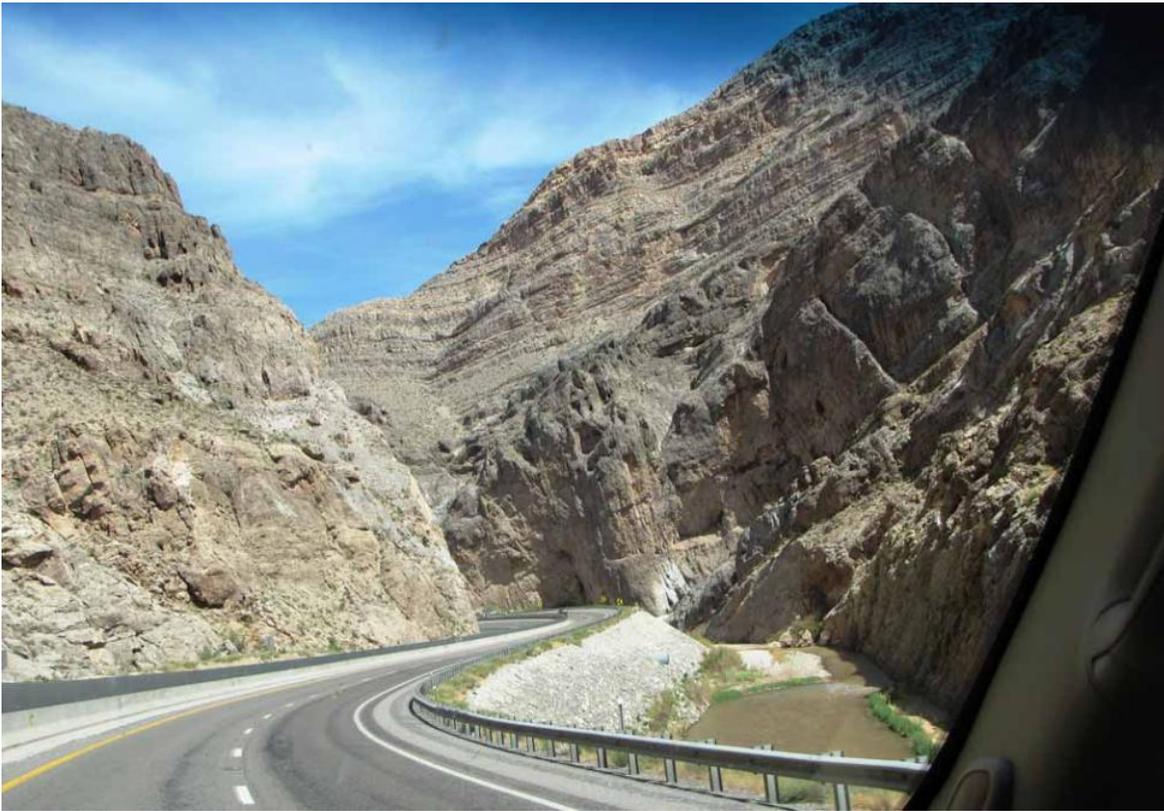
As the 992 loader operators were loading rock trucks, they moved any shot rock aside that was over 4' in diameter. It was later loaded on 50 ton rock trucks and hauled to areas along the roadway that needed riprap protection. After the rock was in place on the slope, the voids were filled with concrete. See sketch 4 for the location of the riprap on the slope. See the photo below that shows actual riprap in place on the roadway slope.
