# MAXIMUM REACH ENTERPRISES

## RIGGING HISTORY OF THE MILLSTONE II STEAM GENERATOR REPLACEMENT PROJECT WATERFORD, CONNECTICUT

### Millstone Nuclear Power Station

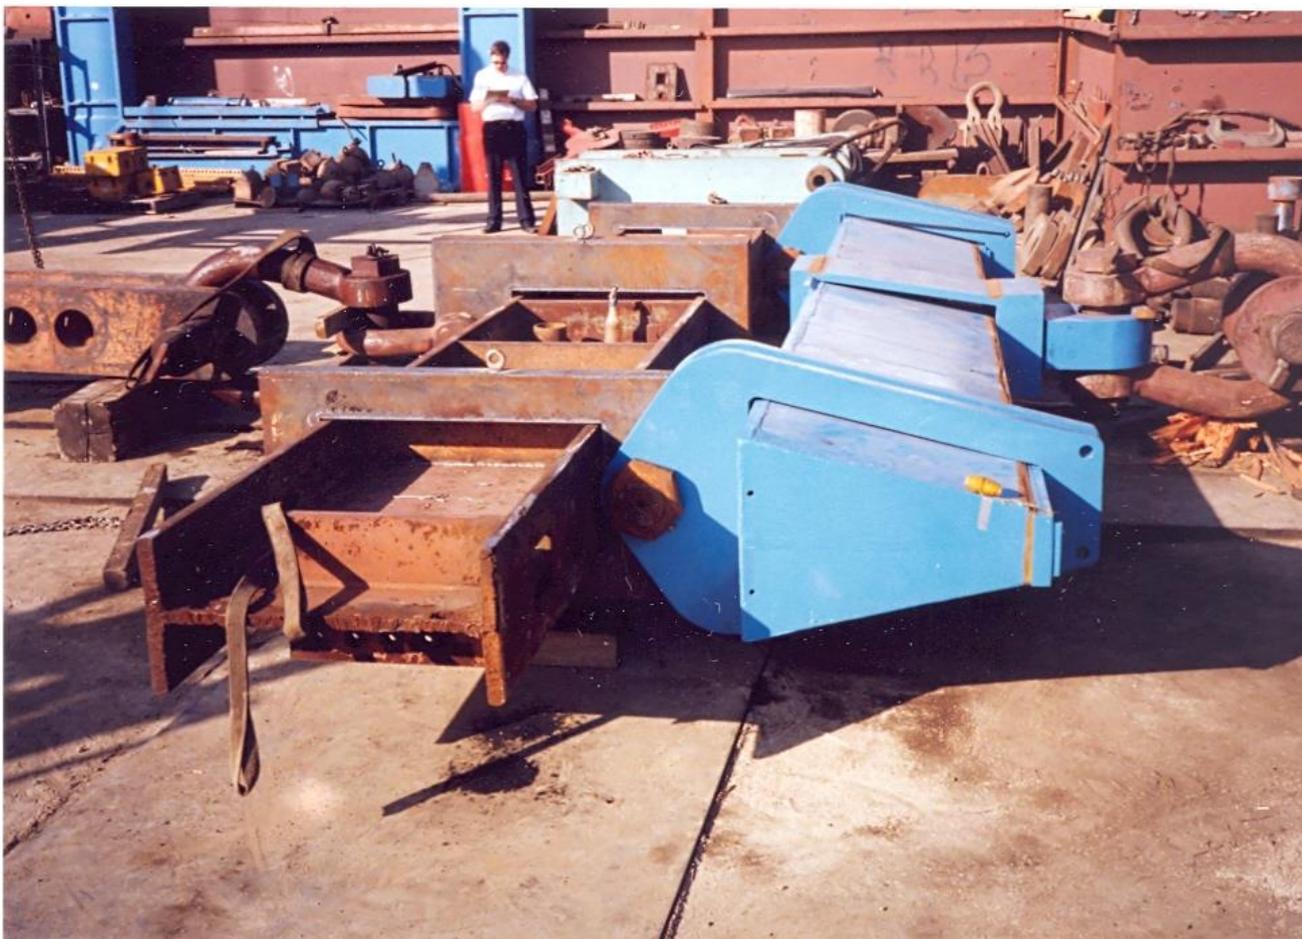
Photo 5

See photo 5 to see the Reliance beam and yokes being load tested.
